Experimental Investigation into Rockfill Dam Failure Initiation by Overtopping

Nasrin Javadi and Tew-Fik Mahdi*

Abstract

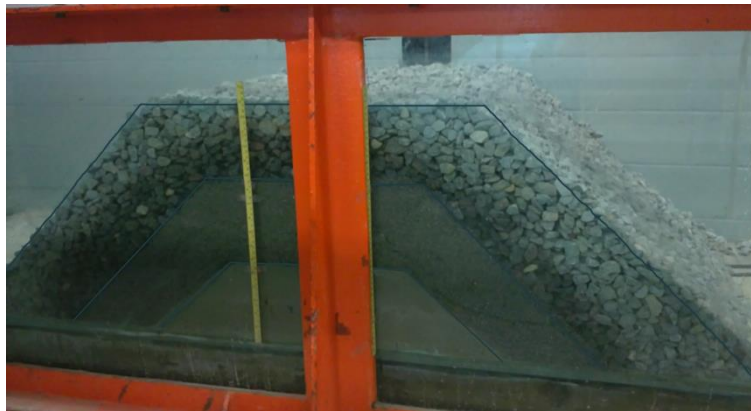
Figure 4: Marks on the glass walls of the channel of the dimensions of the layers

For each model, the predefined dimensions of the layers were marked on the outside of the side wall windows along the channel, to base the construction of the dam upon (Figure 4).

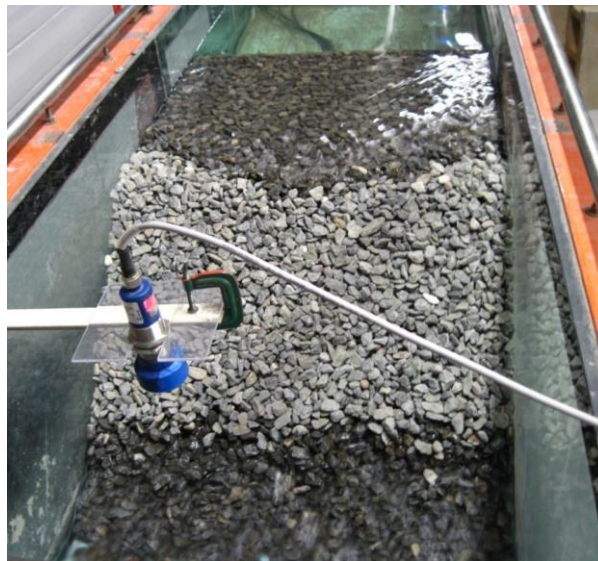
Figure 5: Phase beginning the breach at the foot of the downstream face

The initial condition of the test was characterized by a constant flow of intake, Q_0 . To minimize the relative error on the critical height of the water that causes the initiation of a breach on the downstream face, the flow rate was increased in small increments of $3 \times 10^{-4} \text{ m}^3/\text{s}$, resulting in increased depth of water of $2 \times 10^{-3} \text{ m}$. At each increment of the flow, 10 to 15 minutes was required to stabilize the water level before beginning the measurements. Once the flow is equal to Q_0 , we observe a thin blade at the foot of the downstream face as a result of infiltration into the layer of sand. Once the flow rate increased, the water level crossed the sand/gravel interface and we began to observe flow in the gravel level. The impact of this increase in the water level on the stability of the downstream face depends on the size of the riprap and the geometry of the dam. Once the upstream water level exceeds the critical value, the flow at the foot of the downstream face begins to erode particles. By gradually increasing the flow as illustrated in Figure 5, the flow carries the particles at the bottom of the downstream face (it should be noted that while we were in this phase, the structure remained stable and held its ability to retain water upstream); next, the erosion spreads up the sides, forming a breach. The test was terminated before reaching the final breach.
